Introduction

This notice is intended to inform all consignors, consignees and operators of LLWR approved TC14 and TC19 drums of clamping band failures; remedial actions being taken and advise Customers on actions they should take. Please circulate this information to all relevant personnel within your organisation.

Component Failure

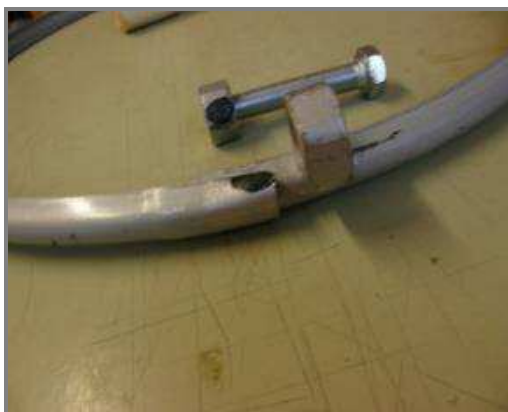
The component failures are all regarding the spot weld used to secure the locking ring nut to the steel (zinc plated) clamping band (see fig 1 and 2 below). In totality LLWR are only aware of six affected TC14 drums, and a single TC19 drum clamping ring out of over 10,000 drums manufactured.

Fig 1 – A clamping band with a failed spot weld (nut detached)

We are investigating an alternative method for fixing the nut to the ring that will be compliant with the existing licence and UN approval to minimise disruption to customers.

LLWR will provide new replacement clamping bands (with the additional welds) to all Customers wishing to replace their existing clamping bands.

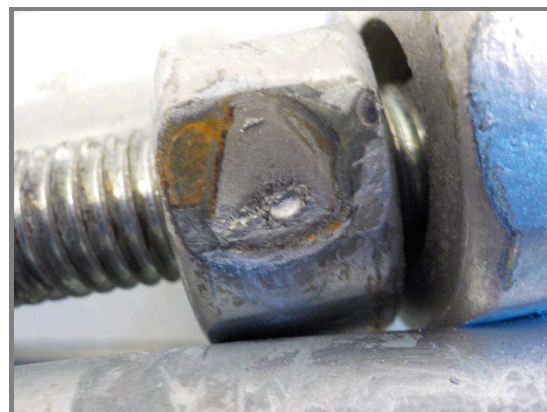
Fig.2 – close up of failed spot weld on nut showing reduced cross-sectional area of bonding
